**CULTURAL LANDSCAPE PLAN
TRAINING FIELD / WINTHROP SQUARE
CHARLESTOWN, MASSACHUSETTS**

February 2014

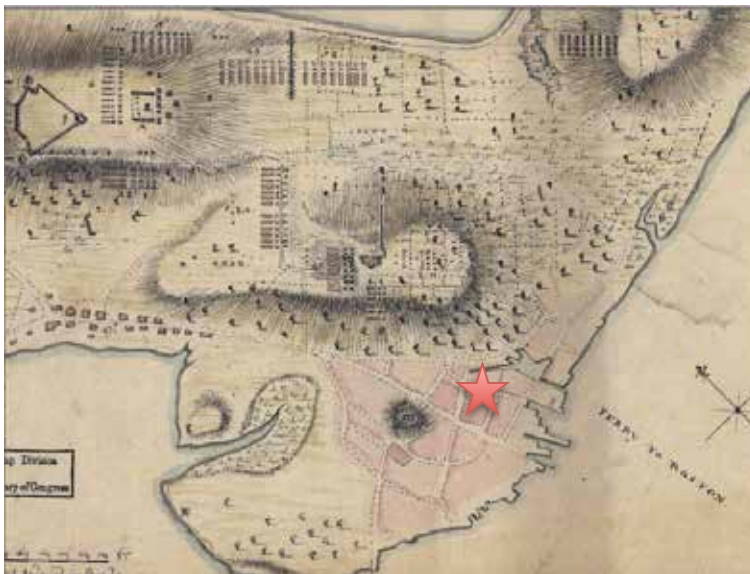
Figure 1.3 - "Plan of the heights of Charles Town, & c. R: W: Lieut.: R.W.F. Boston, Dec 13, 1775." Training Field is located between the heights and the ferry inlet. Red star indicates approximate location of the Training Field.

- 1775 “Plan of the heights of Charles Town, & c. R: W [Richard Williams]: Lieut.: R.W.F. Boston, Dec 13, 1775.” Library of Congress, Maps of North America, 1750-1789, #922. (Figure 1.3)

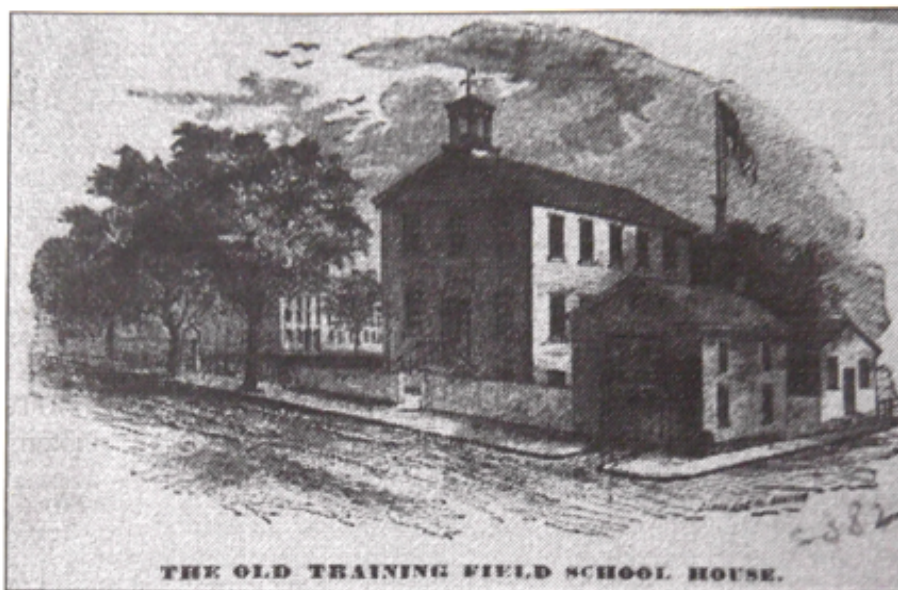
Figure 1.6 - The Warren Engine Company #4 engine house (on corner, ca. 1818), Training Field School (large building, 1827) and gun house (far right, ca. 1832) were located in the southwestern corner of the Training Field. All three buildings were removed ca. 1847. This conjectural sketch shows the size and orientation of the buildings as well as the 19th century vertical wooden fencing in front of the school.

Fencing, Railings, Pillars and Bollards – There has been fencing around the perimeter of the Training Field since at least the mid 19th century. The earliest fences around the Training Field were most likely post and rail fences around the entire Training Field. Figure 1.6 show what appears to be a vertical board fence in front of the Training Field School in the 1830s, which would have made sense to contain the children. Ornate iron fencing with granite posts at major entrances dates to the late 19th century, but has largely been replaced with simpler contemporary metal fencing that is consistent with current Boston Parks and Recreation Department standards for historic parks. All major entrances except the southwest entrance, which was added later, are marked by granite pillars and iron bollards to prevent vehicular access.

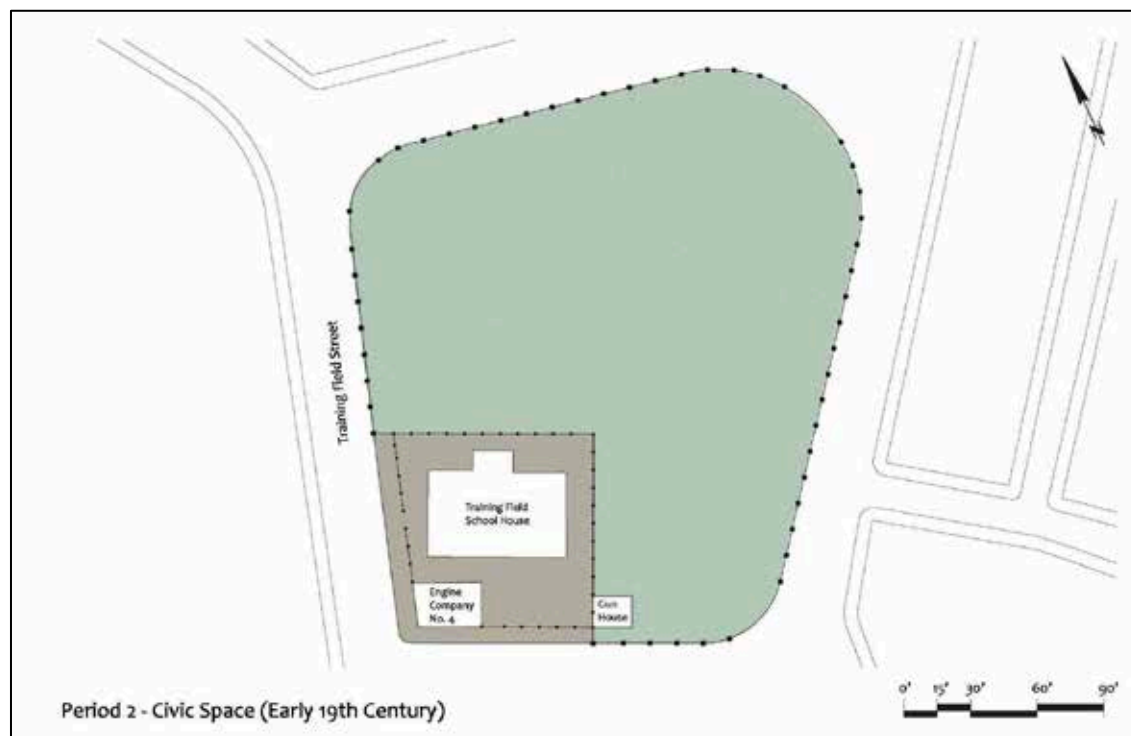
Figure 1.7 - This period plan (ca. 1830s), based on historic maps and images, is conjectural because of the scarce information available for this early period. Key features include the three buildings, the perimeter fence and the fence around the buildings. During this period the Training Field would most likely have had rough grass that was used for multiple purposes, like a 19th century town common. Note: “period plan” is a graphic format used to document the appearance of a landscape during a specific period or date. Using a standard graphic technique makes it easier to compare change over time.

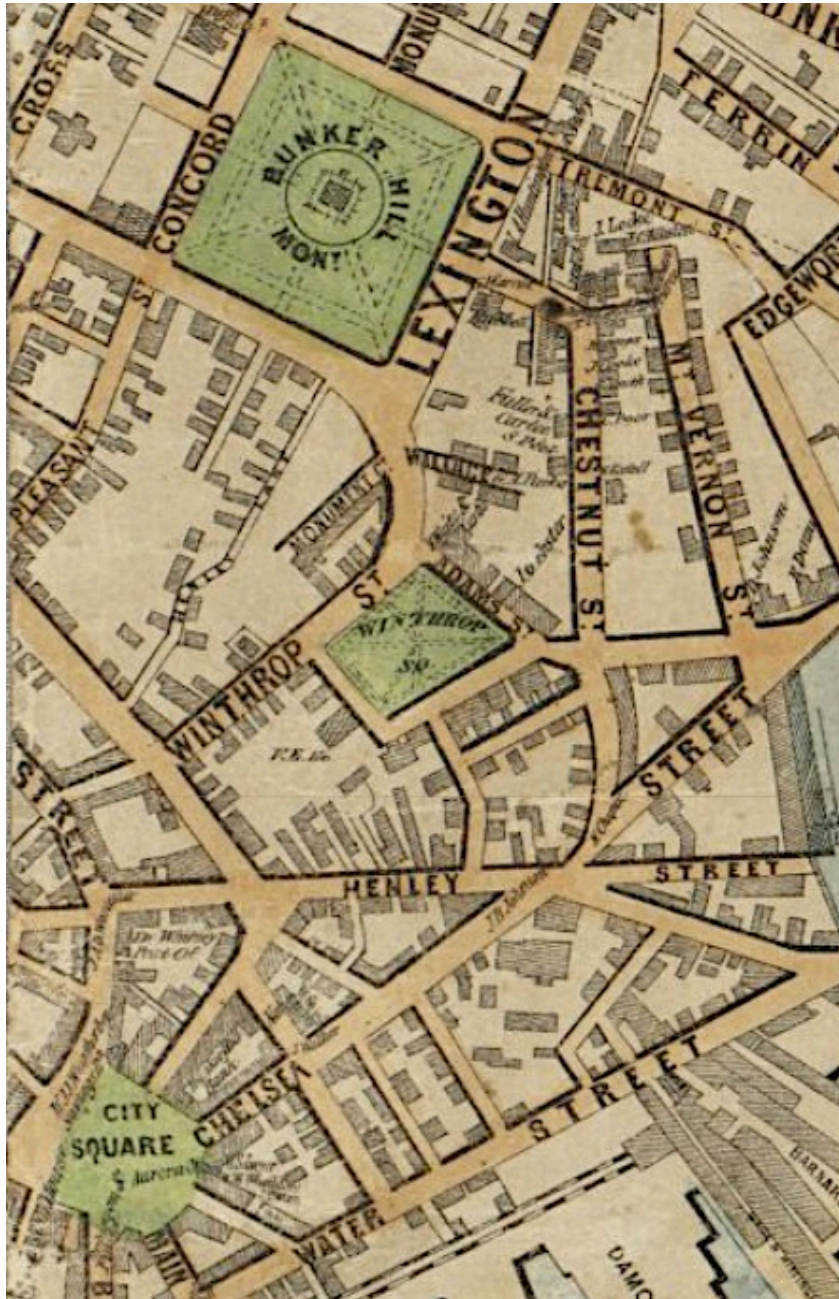
Figure 1.8 - 1852 McIntyre map of Boston showing the Training Field in relation to City Square and the Bunker Hill monument. The three buildings on the Training Field had been removed by this time and the site was becoming more park-like.

- 1852 “Map of the City of Boston and immediate neighborhood” by Henry McIntyre. Boston Public Library, Norman B. Leventhal Map Center. (Figure 1.8)
- 1875 Hopkins. “Atlas of Boston.” (Figure 1.12)

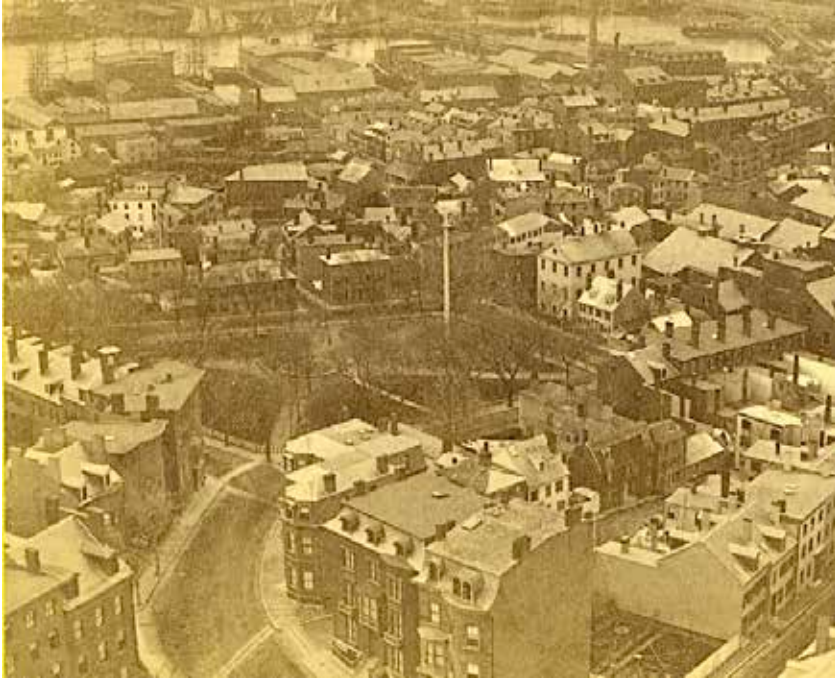
Figure 1.9 - 1860s image from the Bunker Hill monument looking south towards Boston shows the Training Field with radiating path system, central fountain, flagpole and light colored fencing around the perimeter.

- 1860s View of Training Field from Bunker Hill Monument. Historic New England Archives. (Figure 1.9)
- Ca. 1870 - Stereo image from showing the fountain at the Training Field. (Figure 1.10) Charlestown Branch Boston, Public Library.

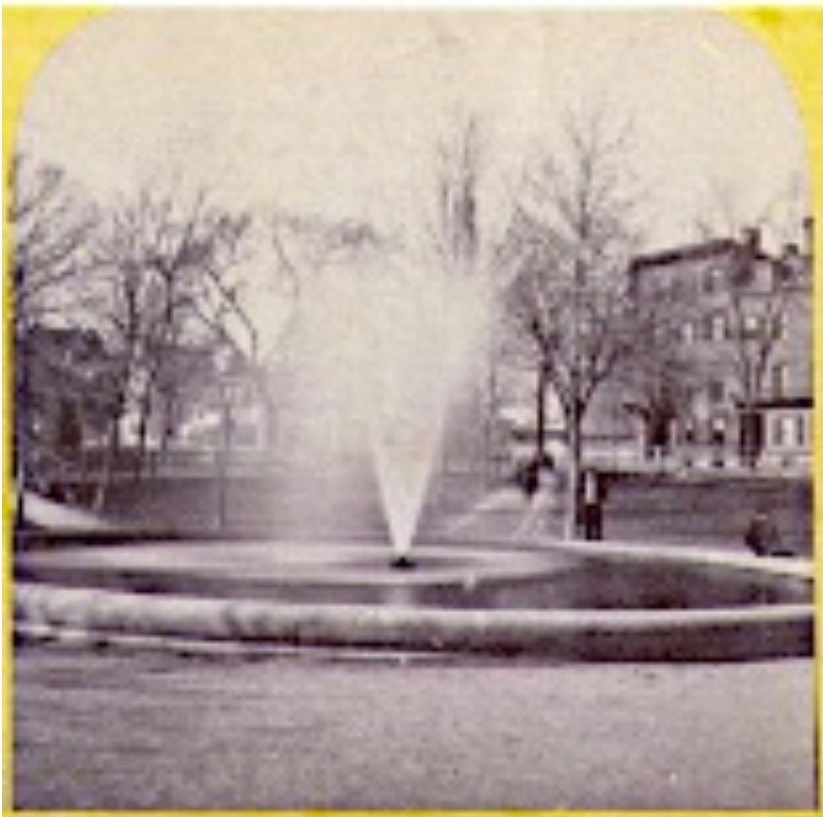
Figure 1.10 - This ca. 1870 image shows fountain, gravel paths and trees, some of which appear to be American elms. View to the northwest.

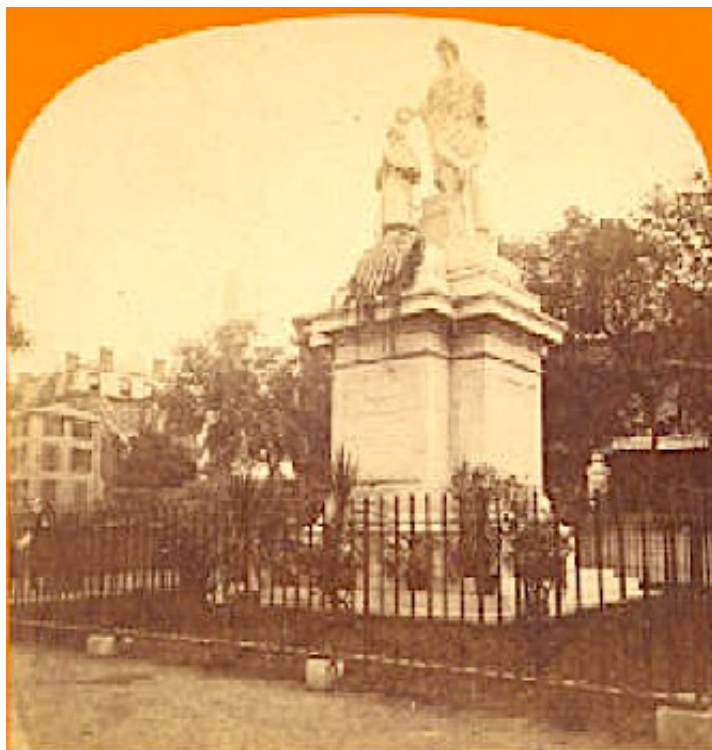
Figure 1.13 - 1875 view of Civil War monument with simple iron fence surrounding it.

- 1875 Civil War monument stereo photograph with orange background. (Figure 1.13)
<http://groups.csail.mit.edu/mac/users/rauch/charlestown/postcards/all.html>

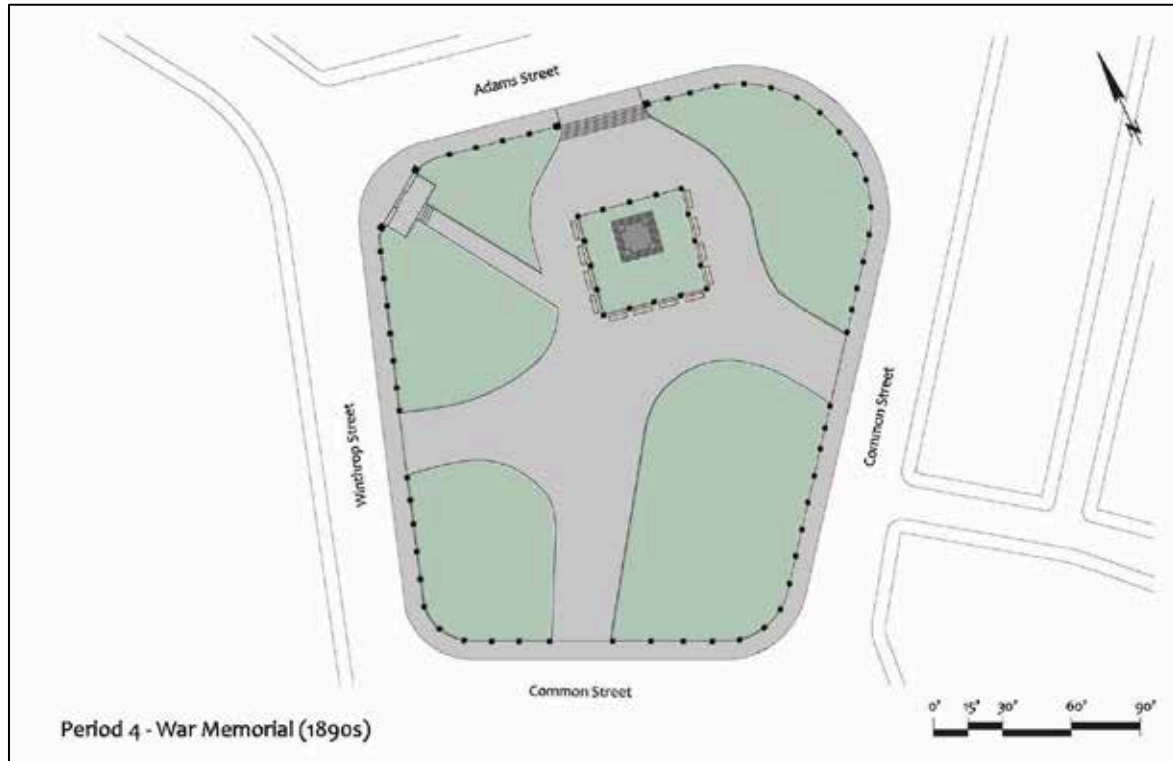
Figure 1.14 - Period plan showing the Civil War monument (1872) in the upper center with the commemorative plaques (1889) at upper left. The path to the upper left was added in the 1890s. These additions transformed the park from an urban square to a commemorative space. Trees are not shown on this plan but appear in photographs of the period.

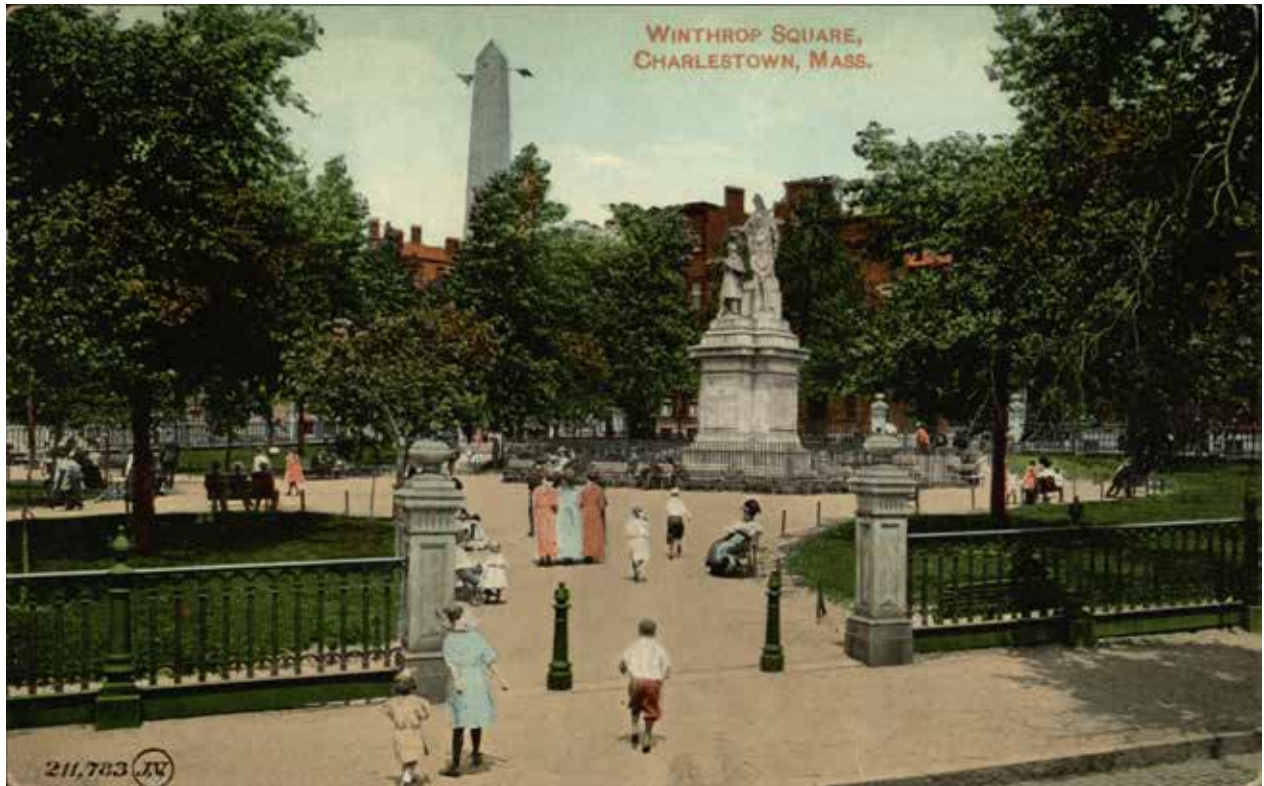
Figure 1.16 - This ca. 1900 view shows details of the original perimeter fence with granite entry posts and bollards, as well as path system, benches, grass and trees. The park is clearly in good condition at this time.

- Ca. 1900 Winthrop Square with Bunker Hill in the background. Card Cow.com. (Figure 1.16)
- Mid 20th c: The following images are part of the Rev. Wolcott Cutler Collection (St. Johns Church Charlestown)

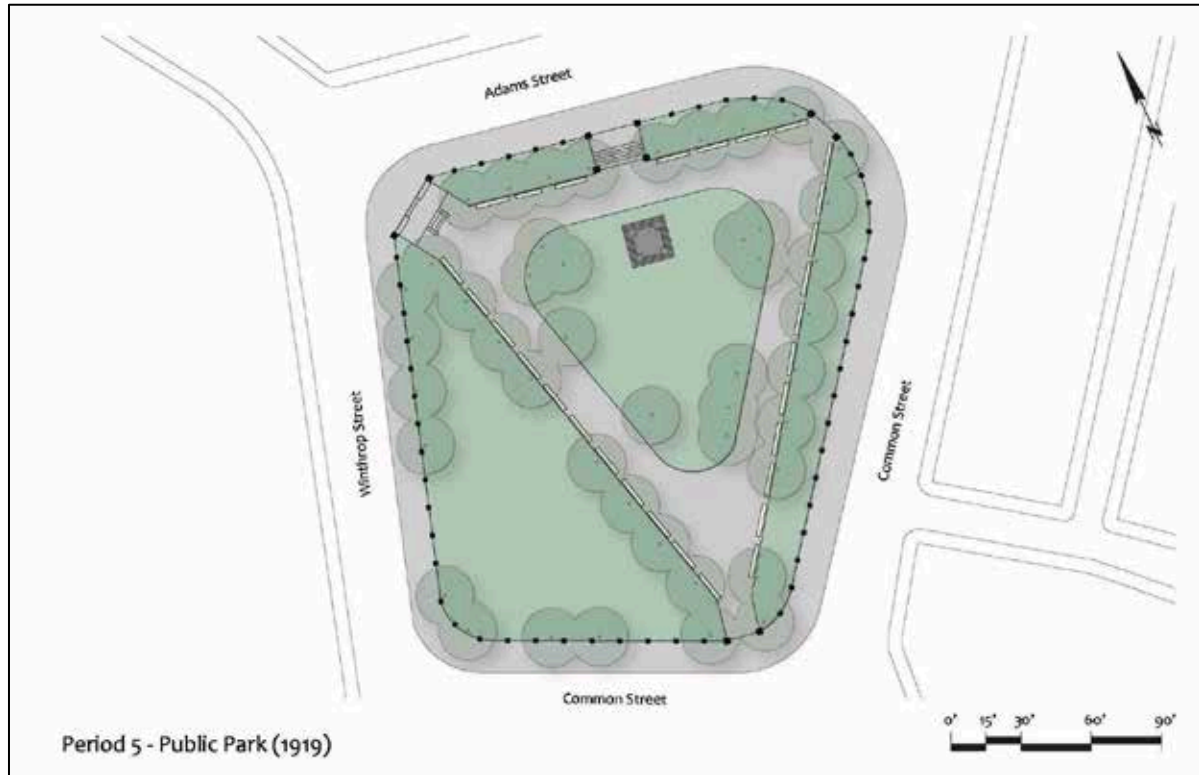
Figure 1.19 - This period plan shows the new design of the Training Field.

Major projects of the 1919 redesign were: reorganizing the circulation system; resodding the entire park; cleaning and repointing the monument; and installing new benches with concrete backs along the main paths. The purpose of the changes was “to make the Training Field a recreation center for adults and not a playground for children.” The total appropriation for Winthrop Square’s post World War I improvements was \$16,000. (BLC Inventory Form)

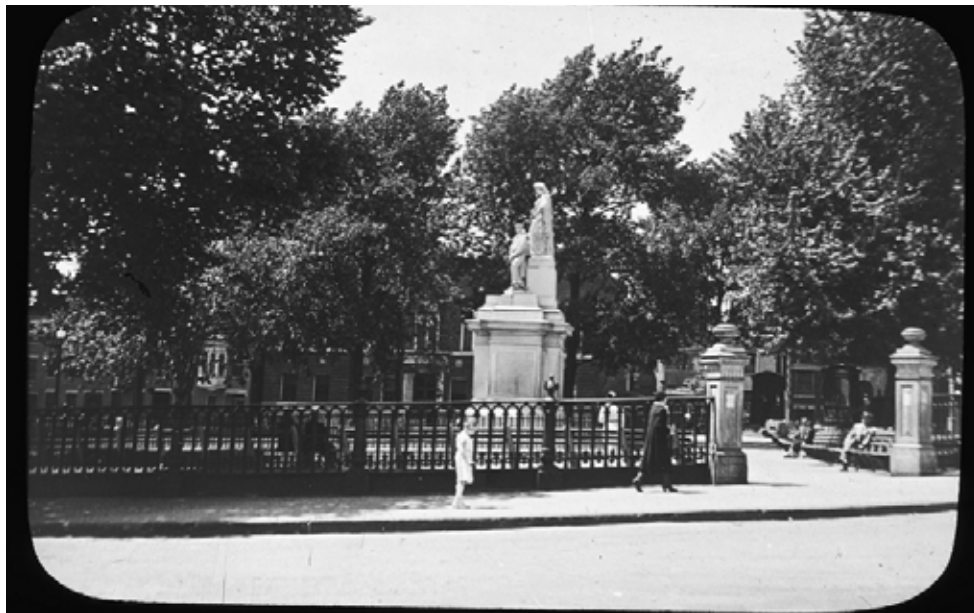
Figure 1.20 - Post 1925. The park remained in good condition through the 1920s. Note the decorative iron fence, continuous benches and heavy tree cover. (BPL Flickr CHA-311-A2)

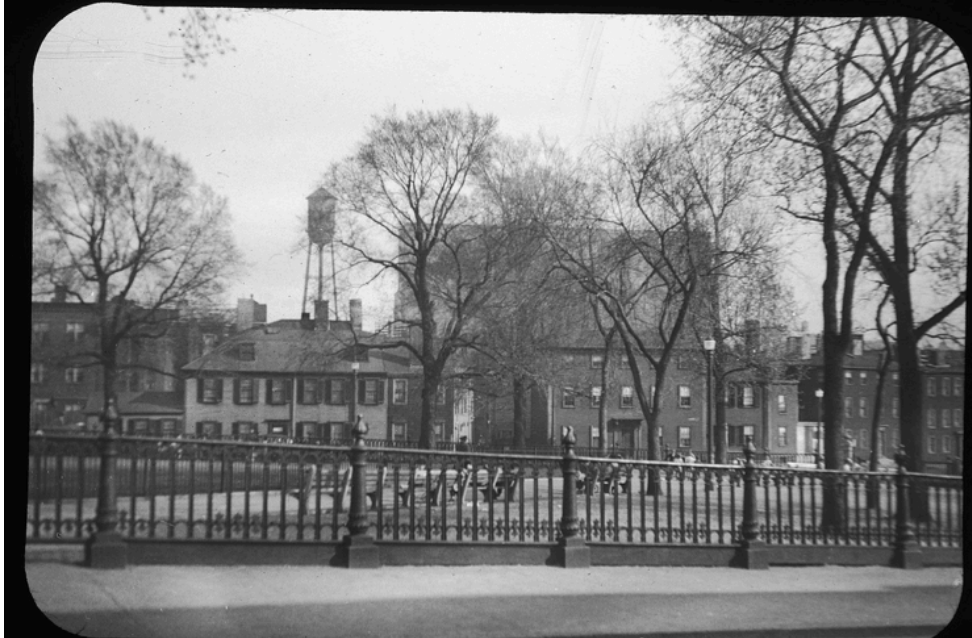
Figure 1.21 – 1944 view of Training Field. Note the decorative fence, which was removed gradually as sections failed. By this time there were fewer benches, placed further apart, and there appear to be fewer trees, some of which are still American elms. (BPL Flickr CHA-313-A1)

During the 1930s and 40s there was little money available for maintenance and improvements, so the park began to deteriorate. The handsome perimeter fence (shown below) was damaged by falling trees during the hurricane of 1938 and over time was replaced by the present simpler and more utilitarian fence.

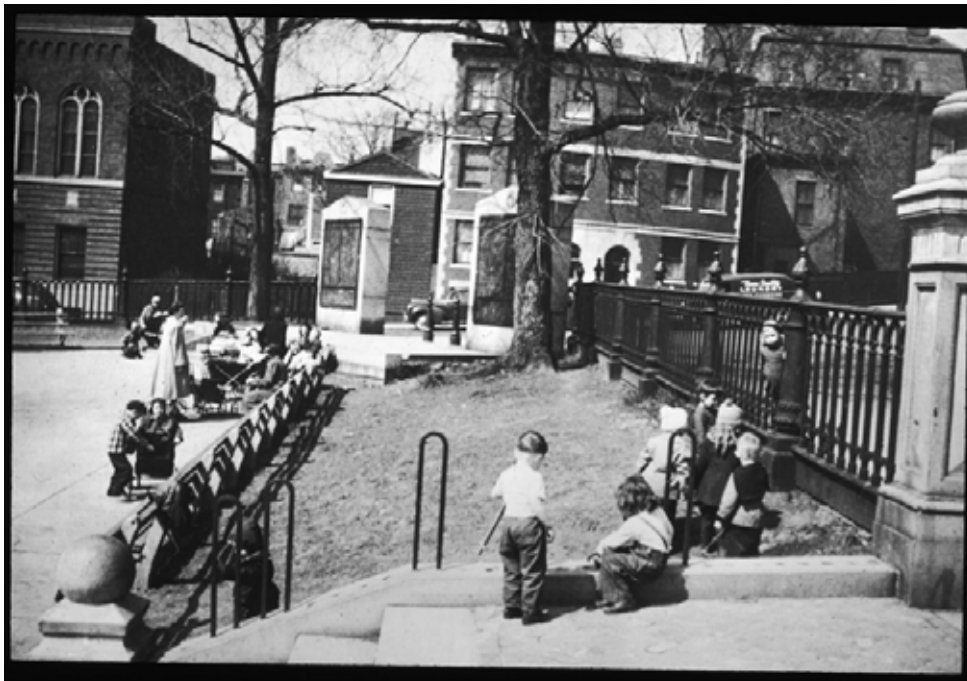
Figure 1.22 – 1950 detail in northern section of the Training Field with original fence at right and memorial plaques in the background. (BPL Flickr CHA-311-B2)

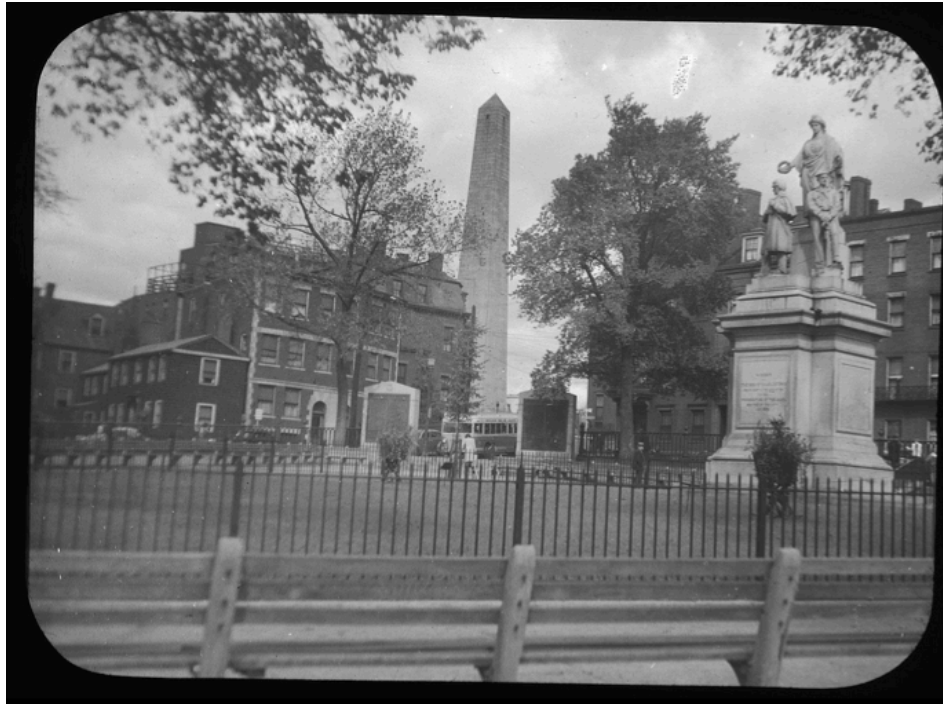
Figure 1.23 - 1940 view showing section of replacement fencing around the Civil War monument with Bunker Hill monument in the background. (BPL Flickr CHA-311-A1)

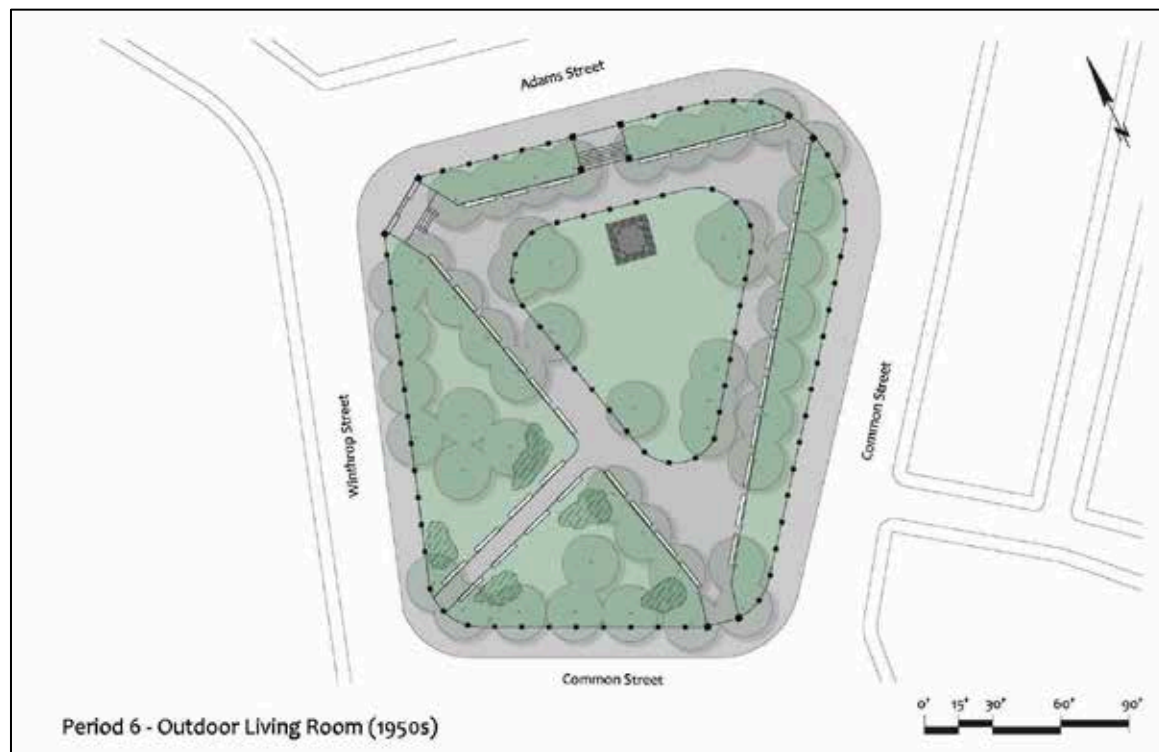
Figure 1.24 - The major changes between 1919 and the 1950s were the gradual removal of the 1872 decorative fence and the addition of a new path in the southwest corner of the park in 1954. Many of the elms died during this period and were replaced by other deciduous trees.

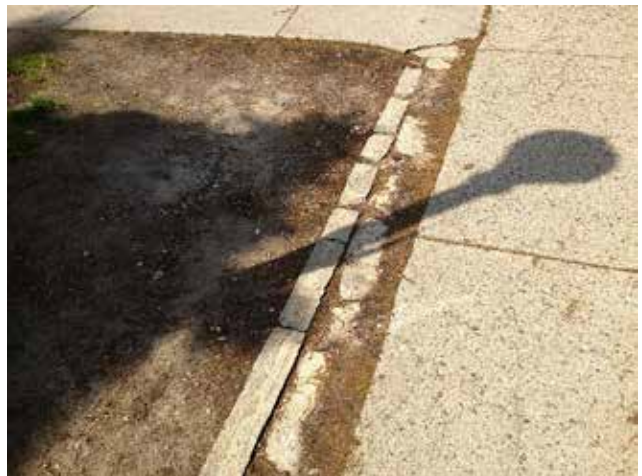
Figure 2.4 - Erosion along path system.

- Add catch basins in key locations to capture storm water before its large volume causes erosion. Add catch basins to prevent drainage that causes icing problems on the walks.
- Clean catch basins in the Training Field and its immediate surroundings, particularly those uphill from the park.
- Re-grade areas to direct storm water into drainage structures or toward the intended path of flow.
- Any plans for substantial excavation require a permit from the City Archaeologist to insure subsoil archaeological resources are not disturbed

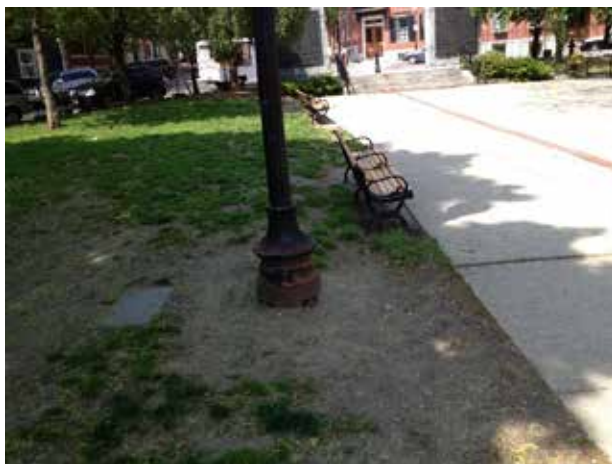
Figure 2.7 – Erosion along the main walkway shoulders.

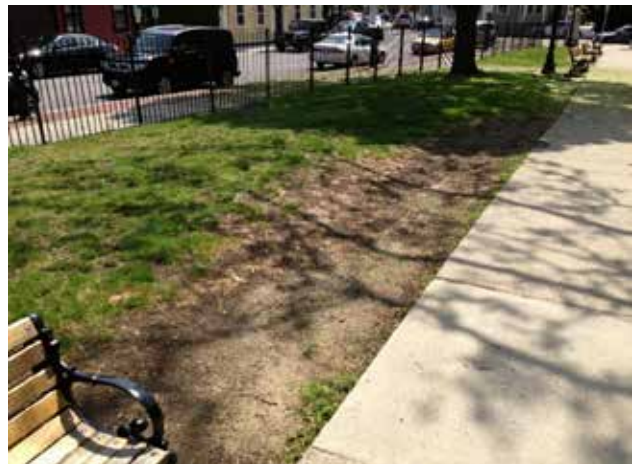
Figure 2.8 – On the east side of the park, water drains south and out to the street.

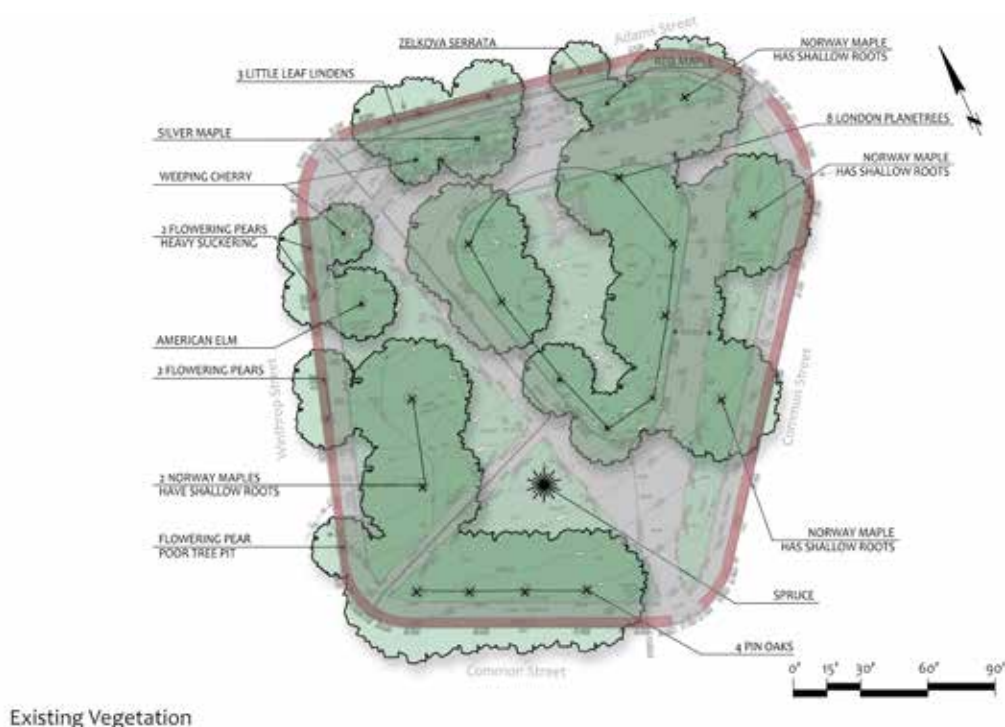
There are also currently a number of Norway maples at the Training Field that pose a problem because their dense shade and shallow roots prevent grass from growing underneath. Norway maples are also weak wooded trees susceptible to storm damage and are very weedy due to the large number of seeds they produce. The present diversity of tree species is appropriate to prevent wholesale loss due to pests or disease, but some of the species found at the Training Field are not strong wooded trees (i.e. flowering pears, silver maple and Norway maple). Also, the perimeter trees growing in tree pits exhibit signs of stress due to urban conditions and insufficient soil volume.

Figure 2.9 – Existing Vegetation, 2013.

- Install an irrigation system for turf areas.
- Re-seed turf areas once soil amendments have been completed.
- Prune Norway maples heavily to thin canopy of trees and allow more light to reach the underlying turf.
- Prune sycamores for the protection of the monument and for unobstructed view of it.
- Plant deciduous trees to fill in holes on the east side of the Training Field. These should be large scale specimen trees (similar in scale to the London planetrees and other trees within Training Field)
- Replace trees as they decline or fail, but do not add more trees that increase the density of tree planting within the park.
- Avoid small ornamental trees that are not consistent with the palette of large deciduous trees and turf.

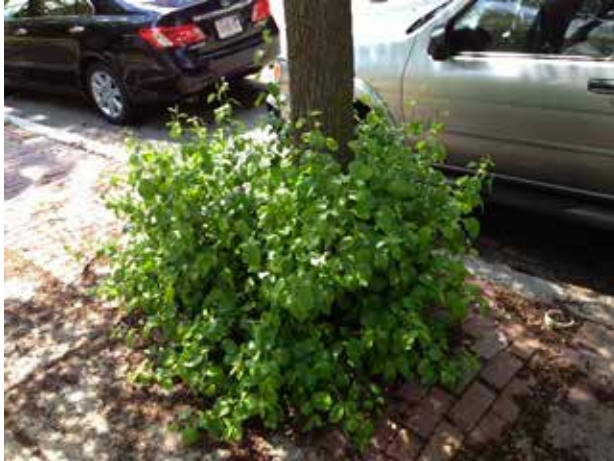
Figure 2.10 – Sucker growth impedes pedestrian travel and is unsightly. Brick pavers in tree pits are heaved by tree roots.

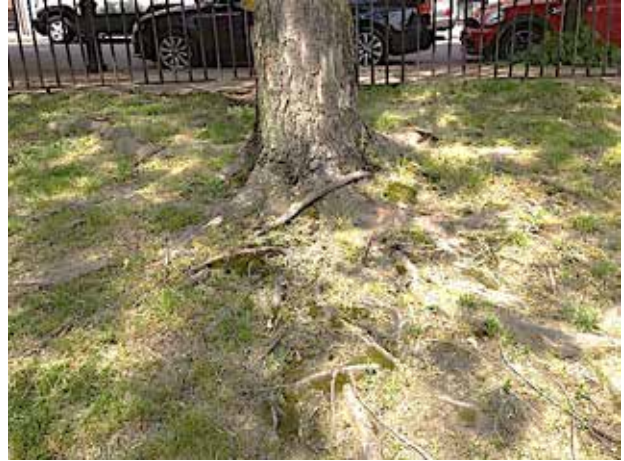
Figure 2.11 – Many shallow-rooted trees can buckle sidewalks, cause mowing or tripping hazards, prevent other vegetation – including lawn – from growing under them, and contribute to soil erosion.

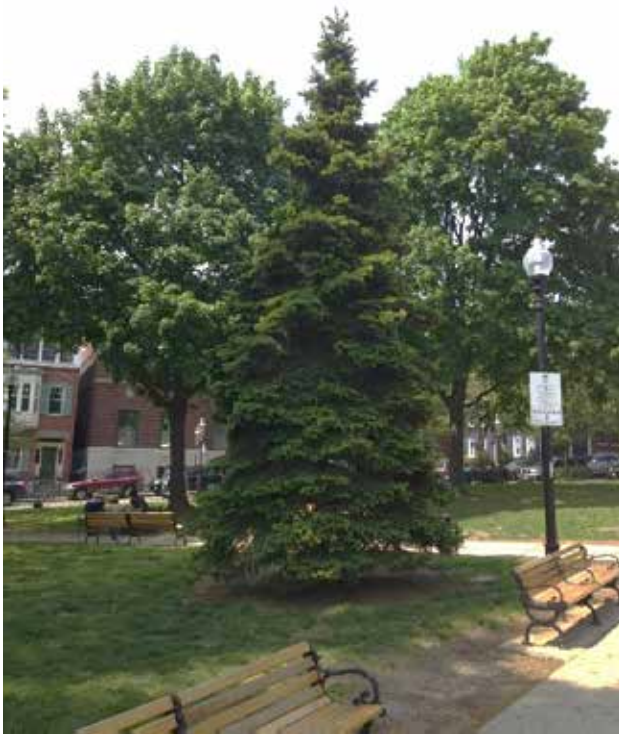
Figure 2.12 - A spruce exists in the southern center portion of the training field. It blocks views and was not part of the historic landscape.

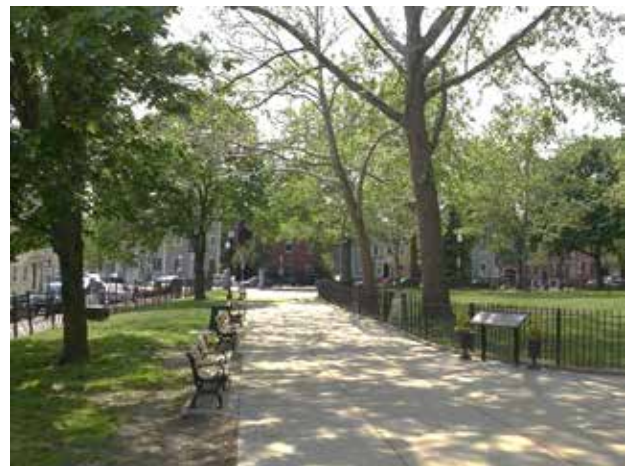
Figure 2.13 – London Planetrees punctuate the central lawn and monument area.

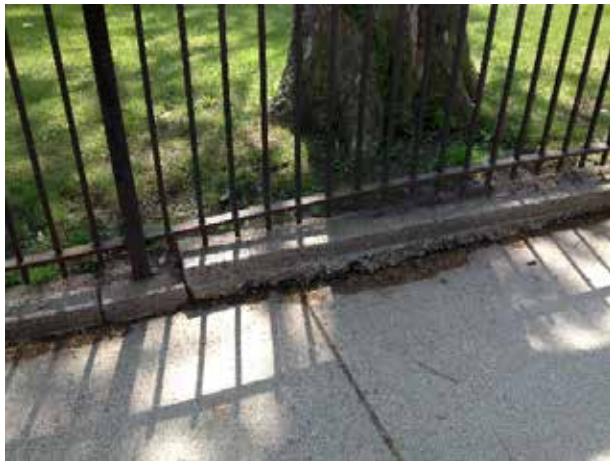
Figure 2.15 - The concrete curb at the base of the central fence has heaved and cracked.

- Replace the concrete curb under the fence around the monument with granite curbing to be a more durable material, consistent with the other small-scale park curbs, and more in keeping with the significance of the monument.

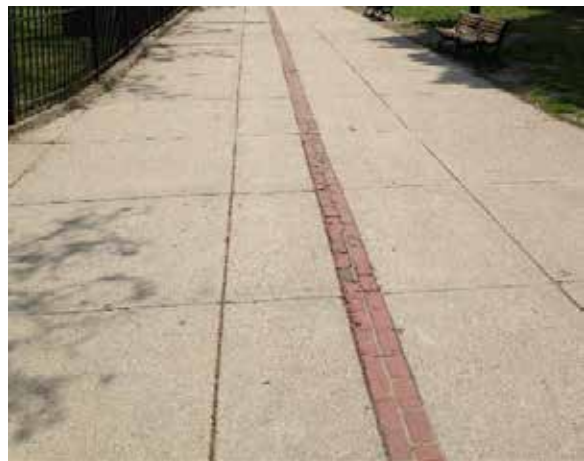
Figure 2.16 – The brick Freedom Trail pavement is cracked in many areas.

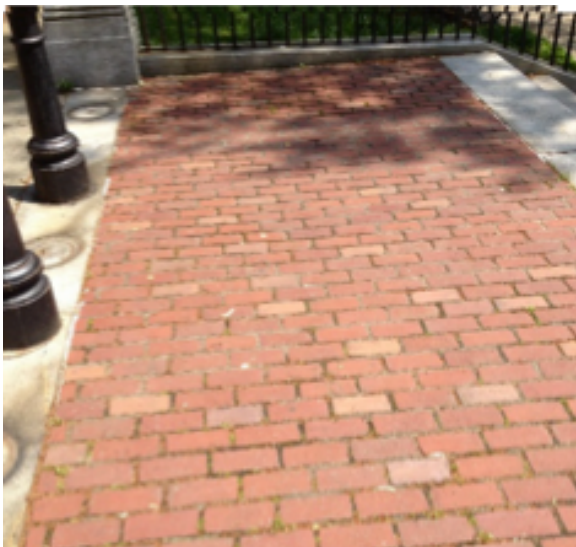
Figure 2.17 - Bricks highlight entries.

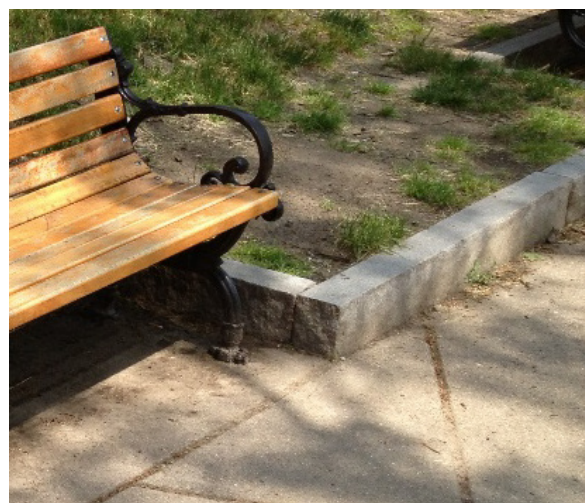
Figure 2.18 - Granite curbs border walks in the northern portion of the park.

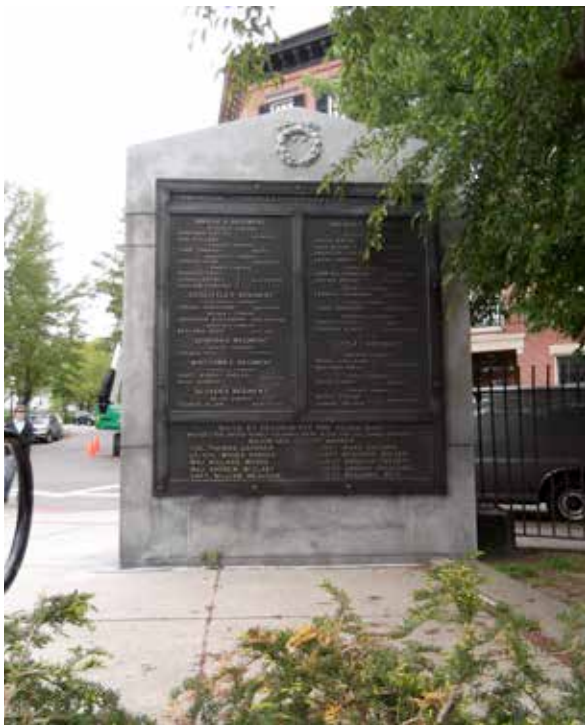
Figure 2.20 – The two bronze plaques in the northwest corner of the Training Field commemorate Revolutionary War soldiers.

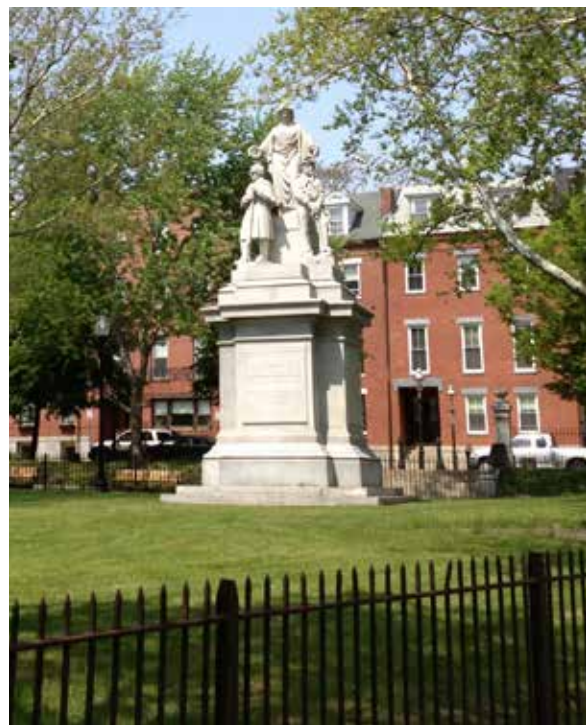
Figure 2.21 - The recently restored soldiers and sailors monument by sculptor Martin Milmore is the focal point of the Training Field.

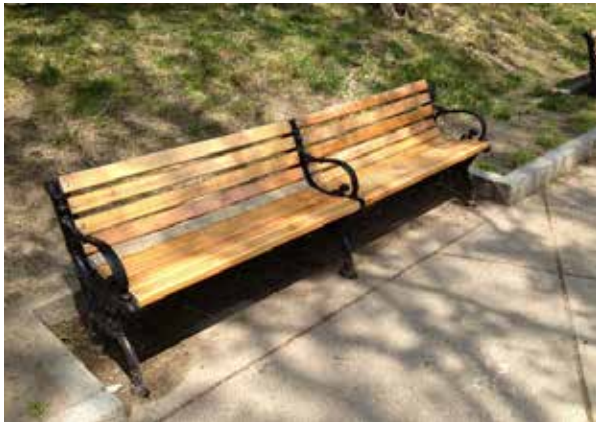
Figure 2.22 – Varnish on the wood bench slats is failing and the benches lack wheelchair companion space.

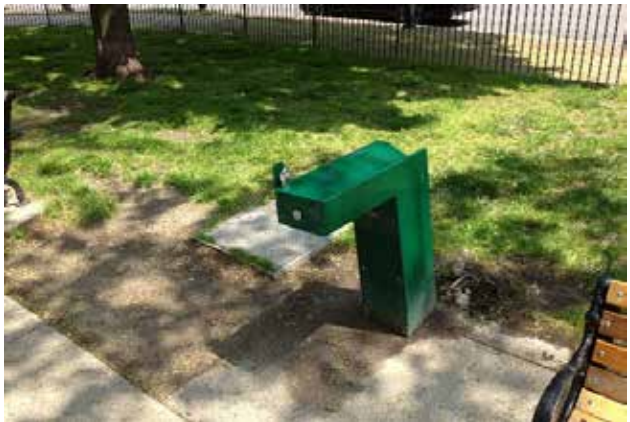
Figure 2.23 - Water fountain is modern in appearance and does not drain to a piped system.

- Accessible drinking fountain should be cast iron, painted black, drained to a dry well or sewer.
- Paint light poles black.
- Paint stair railings in northwest corner and north center of park.
- Replace the deteriorated cast iron bollards with ones of a similar design.
- Remove the trash receptacles from visually prominent locations. Replace with new solar compacting models painted black.
- Refinish wood slats on benches or consider replacement with wood that does not need varnish.
- Replace park identification and regulatory signage at the park perimeter and within that is similar to other historic parks in Boston.

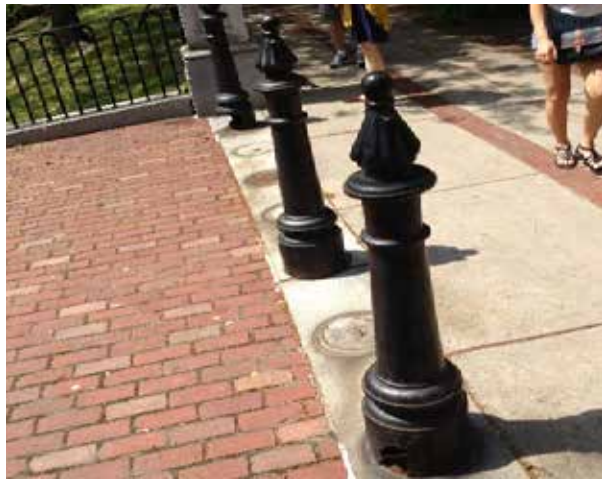
Figure 2.24 – Numerous bollards are missing and others are in poor condition.

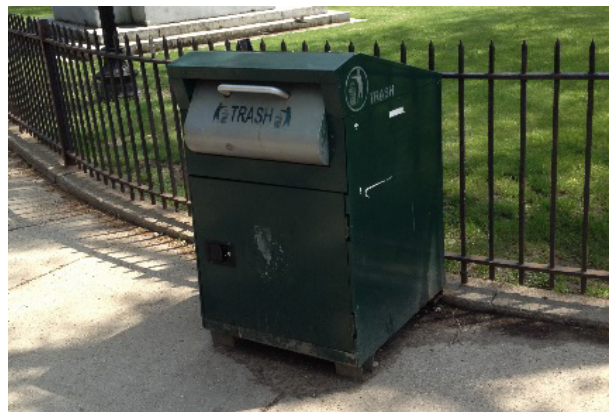
Figure 2.25 - Solar compacting trash receptacles are in visually prominent locations and do not fit the historic aesthetic of the park.

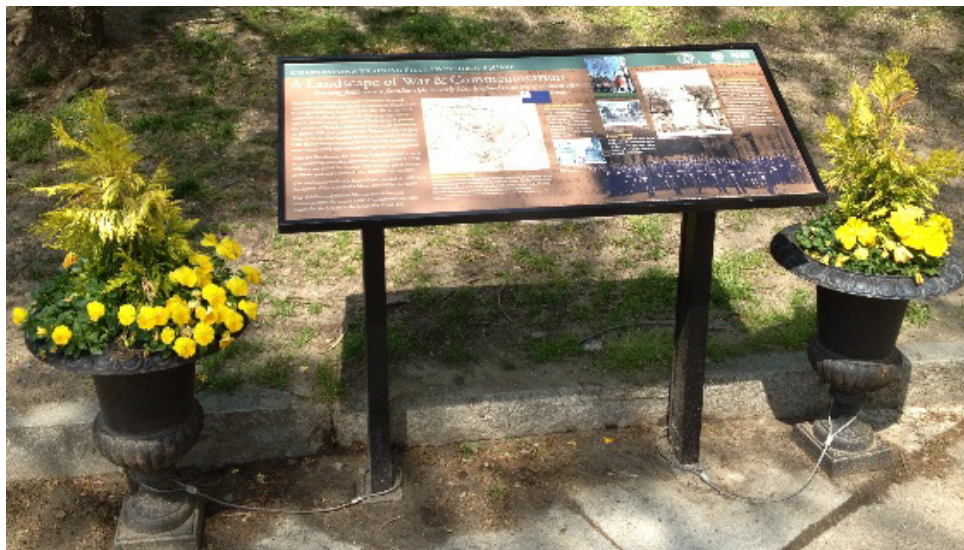
Figure 2.26 – New interpretive signage with cast iron urns.

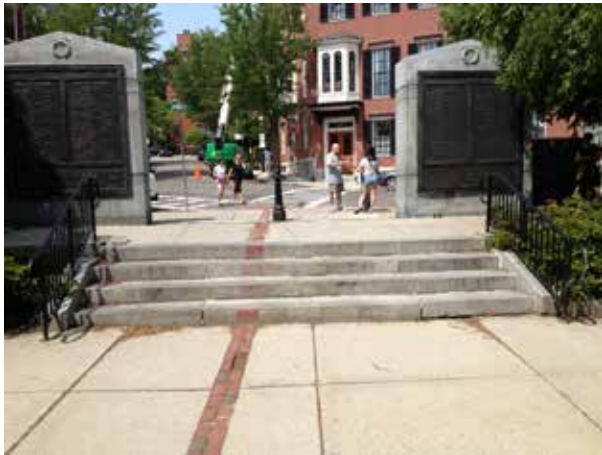
Figure 2.27 - Northwest corner and north entrances are not universally accessible due to steps. Bricks indicate Freedom Trail route.

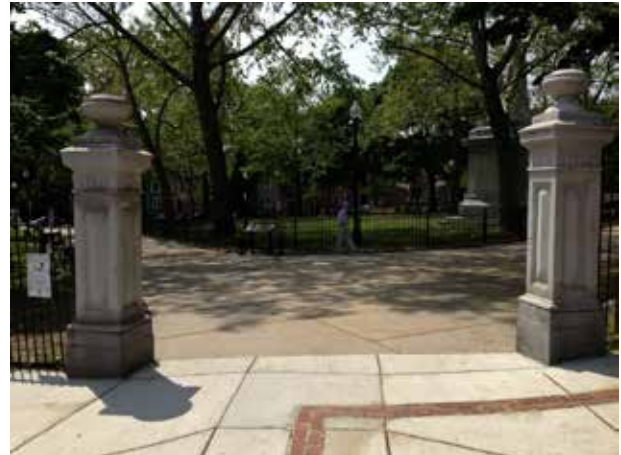
Figure 2.28 - Barrier free access.

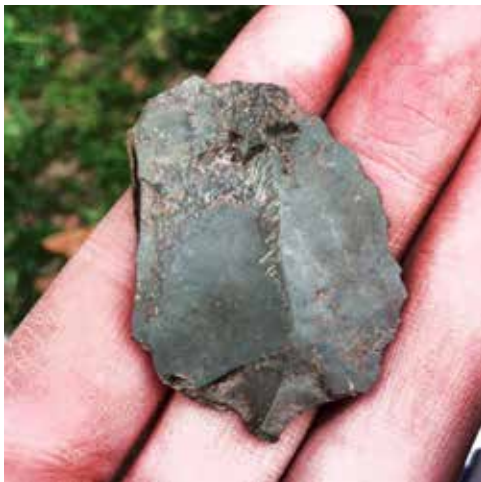
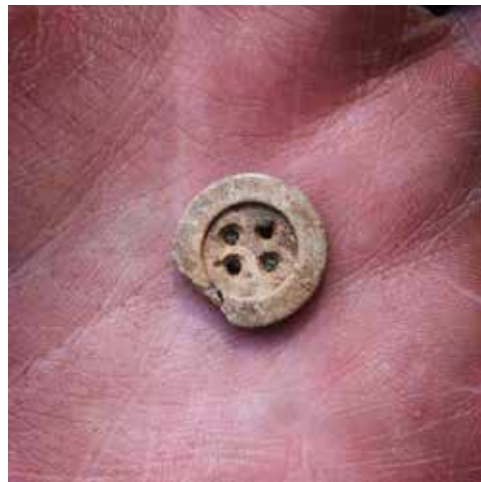
Figure 2.31 & 2.32 – Sample findings: stone flake and button.

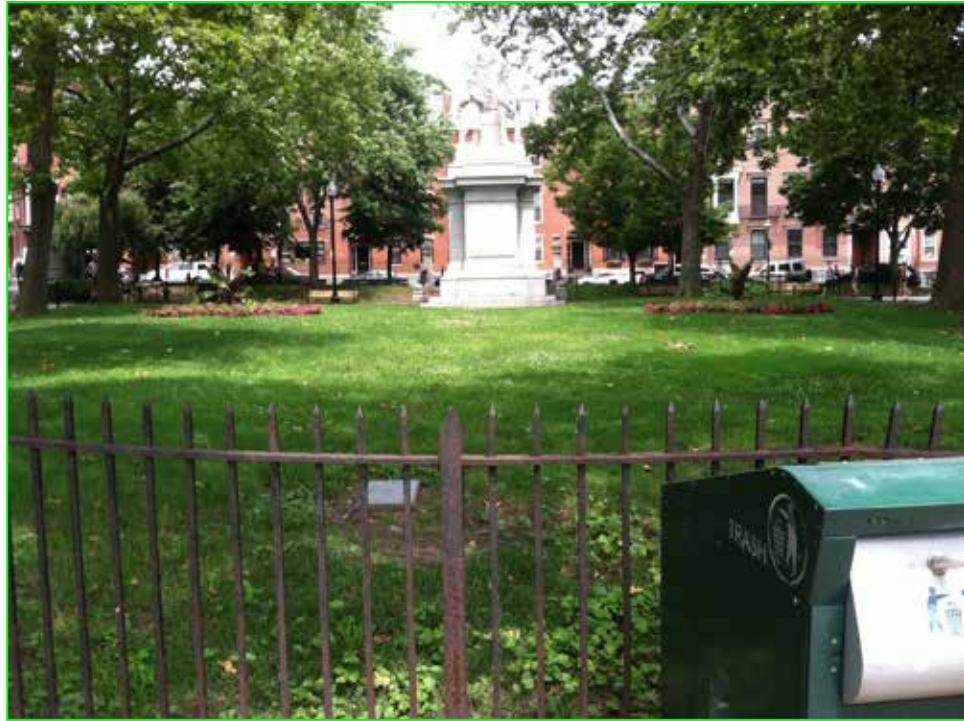
Winthrop Square - June 4th, 2013 Initial Site Observation Comments:

- During my initial meeting with Margaret and visual inspection of the site, I found it to be neat and clean in appearance. The site is located just below the Bunker Hill Monument, is topographically a gradual slope, and is located in full sun.
- The size of the site is .89 acres approximately half of which is under hardscape.
- The existing tree collection throughout looked to be in good general health with all trees in full leaf and most trees exhibiting a proper root flare. Some trees however did exhibit girdling and encircling roots and some had been removed.
- The existing turf overall has a patchy consistency throughout. The exception being **Area #3** which had a full dense turf cover.
- Many areas exhibited signs of soil erosion and exposed soil roots.
